**ARKANSAS STATE HOSPITAL (ASH) – Patient Units 1, 2, 3 & 4**  
**Buildings**

Building Location: 4313 W Markham Street Little Rock, Arkansas

Date of Site Visit: 9/07/06

**Field Notes, Background & General Observations**

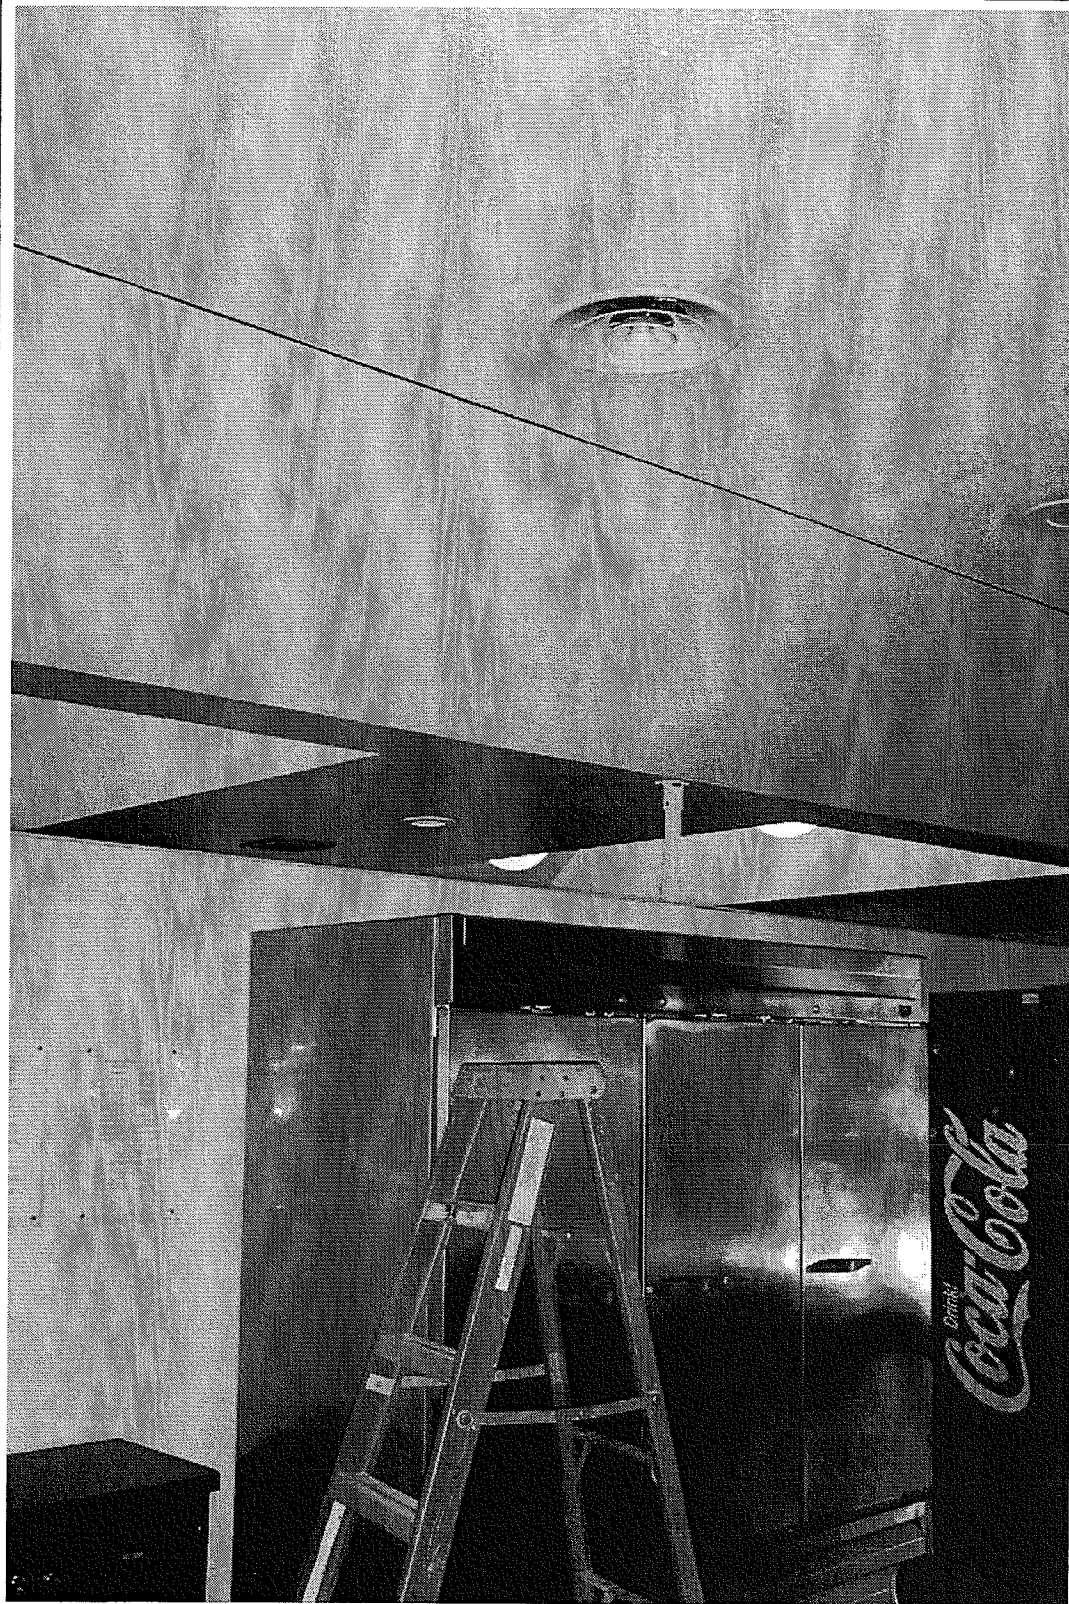
Photo 39. Canteen Bldg. Dining Area - Location of dust sample #1 (top of refrigerator unit)

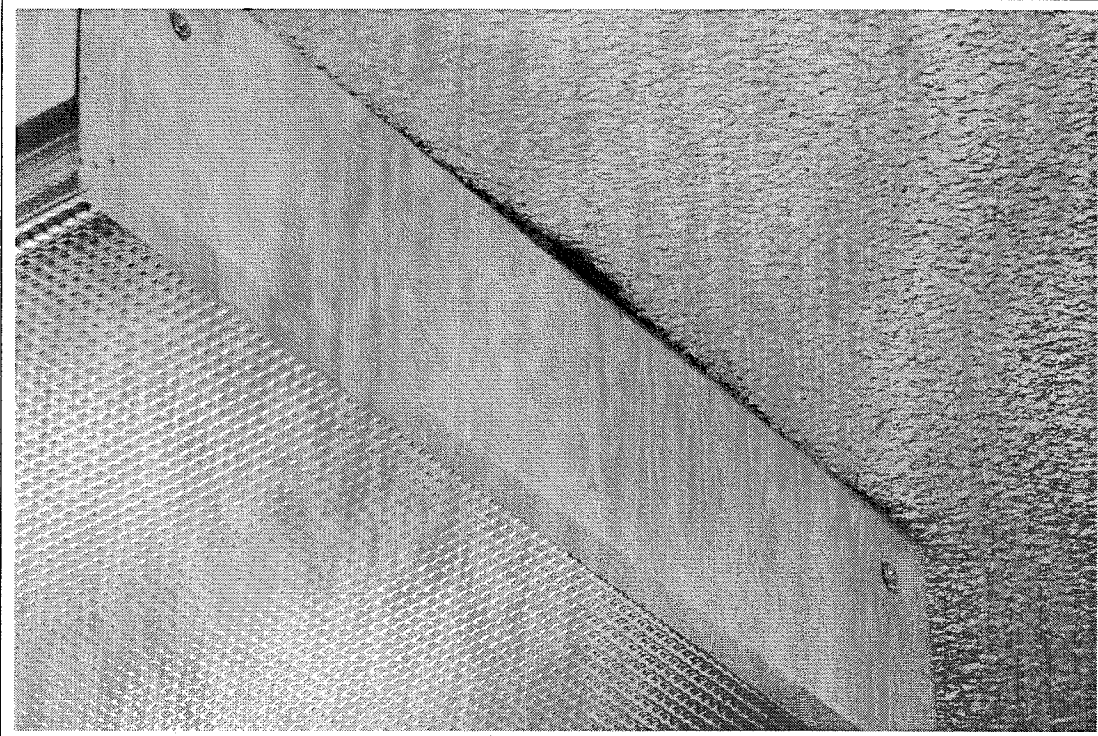
Photo 40. Nursing Administration Bldg., office off east hall - View of damaged acoustical plaster at fluorescent light fixture

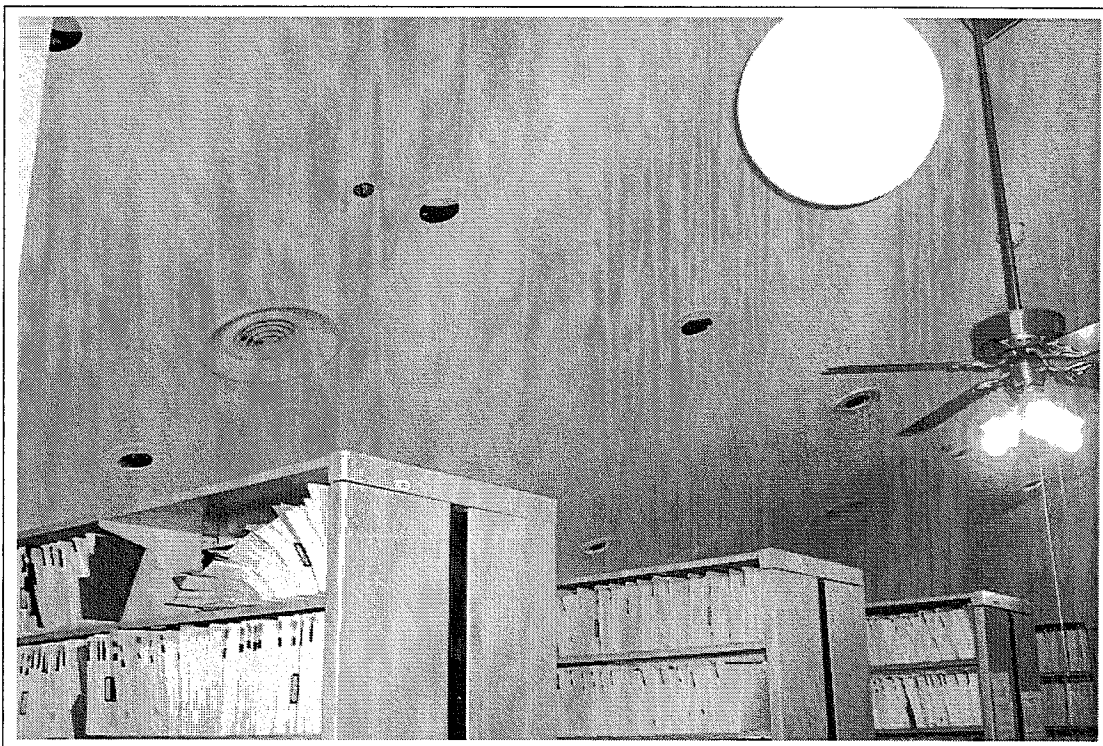
Photo 41. Admissions Bldg. Medical Records Area - General location of dust sample #2 (top of file cabinets)

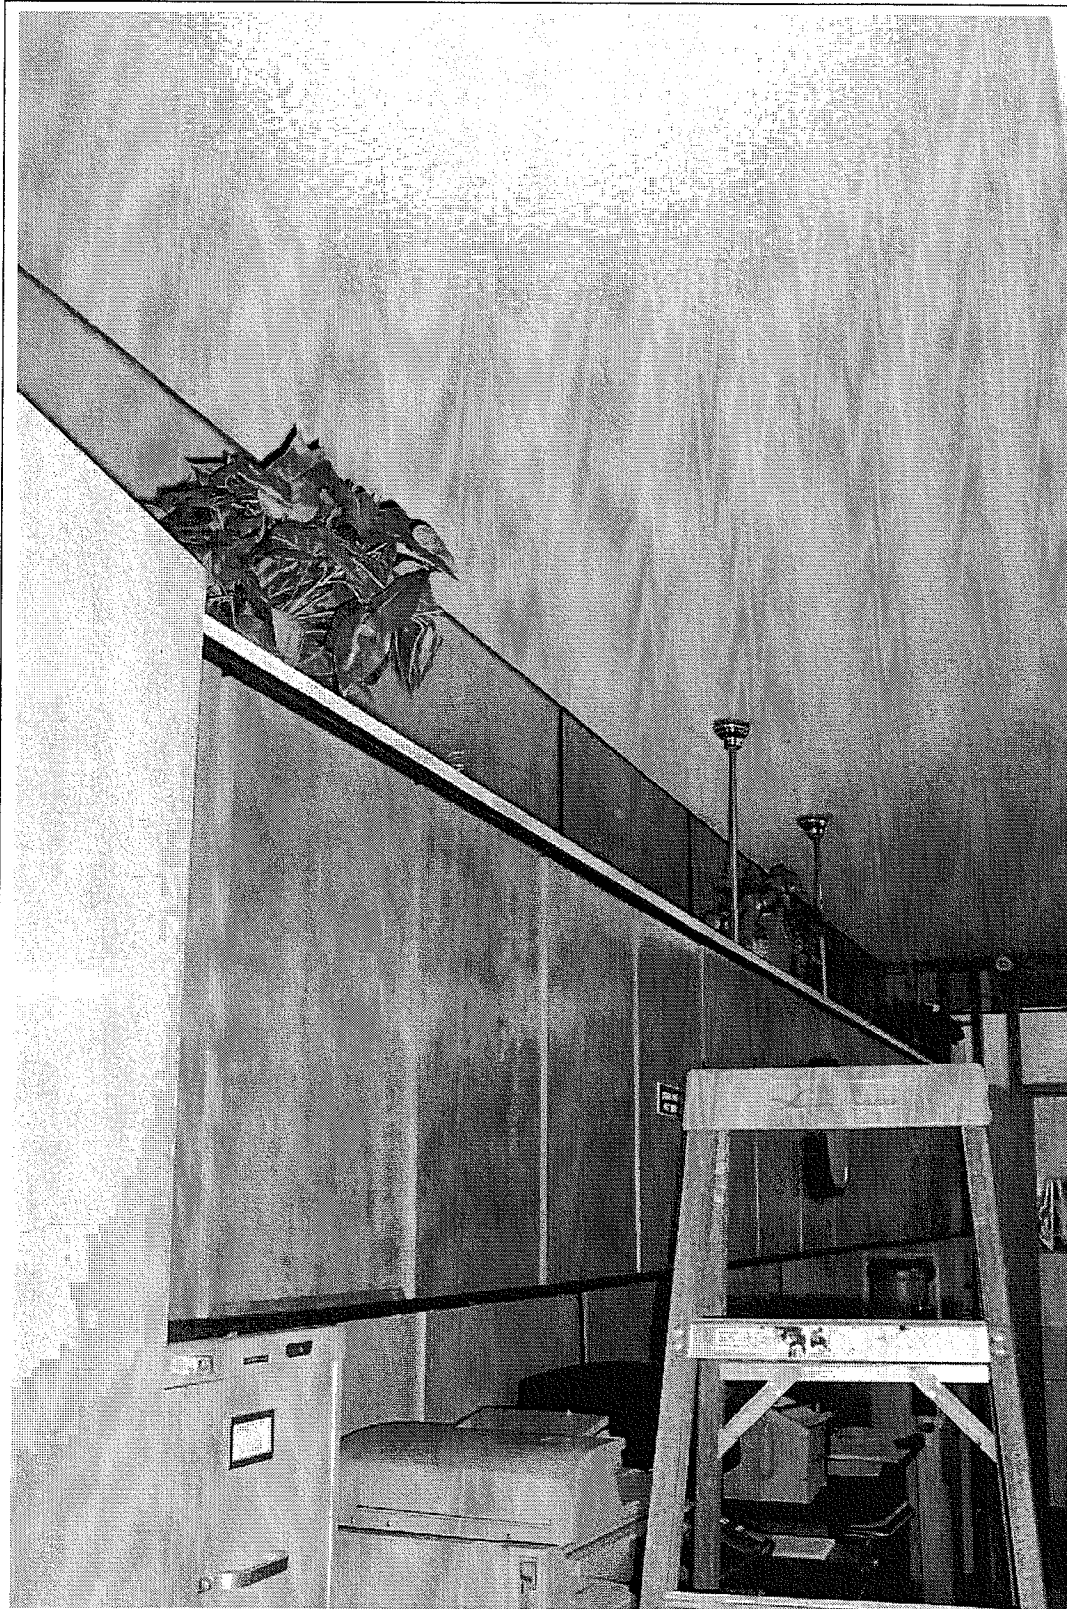
Photo 42. Admissions Bldg. front desk area - General location of dust sample #1 (top of back wall cabinets)
